M5 Slab Replacement Project

CASE STUDY M5 Slab Replacement Project

This particular case study is in reference to a section of pavement with dimensions of approximate length of 11.4m and an overall width of 3.5m. The slab section is located beneath Moorebank Avenue Bridge.

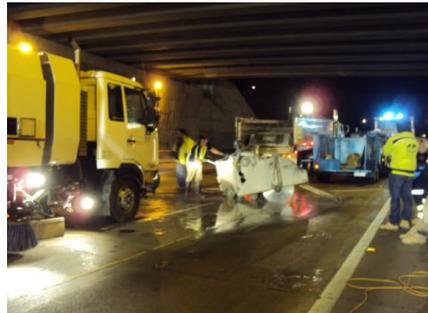
Saw cutting of the slabs commencement immediately around the perimeter and along the P8 joints (refer to *appendix A*). Additional saw cuts were installed at the western end and lifting plates were installed. This was done in an effort to expedite the first panel demolition in order to give sufficient time for managerial staff and the client representative to evaluate the existing base course. Removal of this panel was unsuccessful due to the strong bond between the bottom of the slab and the top of the base course.

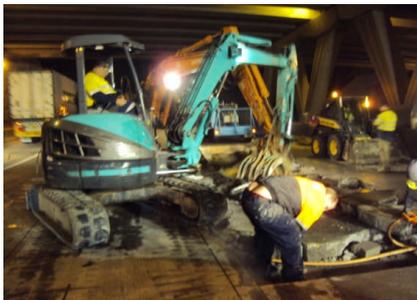
It was discovered that there was existing lean mix beneath the concrete panel and therefore no excavation and installation of lean mix was required.

Demolition was completed within a 70 minute period due to the bond between the existing slab and lean mix beneath. Also compounding to the problem was the over head bridge imposing a height restriction on the plant required for the task which caused delays during loading of the trucks. Demolition on other projects without these restrictions was completed within a 15-20 minute time frame.

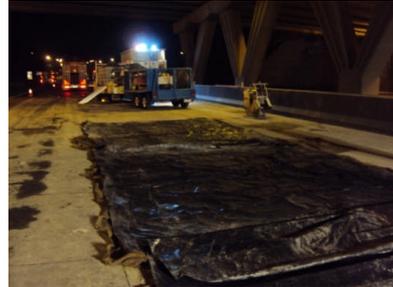
Upon finishing of the slab, curing compound, damp hessian (overlapped by 300mm) and 2µm black buildings plastic was laid over the slab completed in order to aid in the curing process.

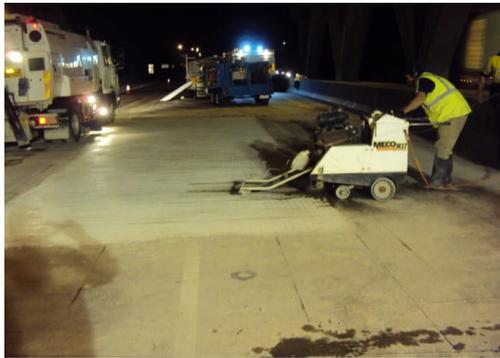
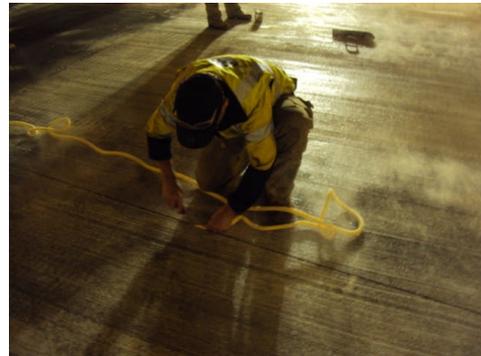
Once the concrete slab had what we believed to be sufficient curing time, saw cutting commenced. The client representative requested that only detail P8/1 be completed (refer to appendix A).
