CASE STUDY M1 Slab Replacement Project

Roadtek QLD

Antoun Civil Engineering (Aust) Pty Ltd

ANTOUN CIVIL ENGINEERING (AUST) PTY LTD FOR ROADTEK QLD

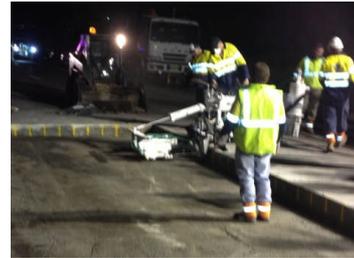
The existing adjacent slab faces parallel to the flow of traffic were drilled using a 2 gang *Minnich Drill*®. This drill was implored to drill 16mm diameter hole, 300mm deep in less than 10 seconds per hole with no form of heavy manual handling.

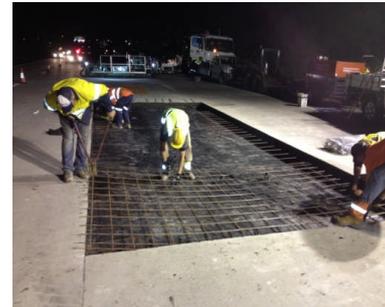
A plastic bond breaker was then installed spanning the full length and width of the slab to be replaced. Any additional plastic was cut away with all additional plastic lapped at a rate of 600mm per joint. Joints were taped in place.
